6.5 FURNITURE, FIXTURES, EQUIPMENT AND CONTENTS

6.5.2 BOOKCASES, SHELVING

6.5.2.1 BOOKSHELVES

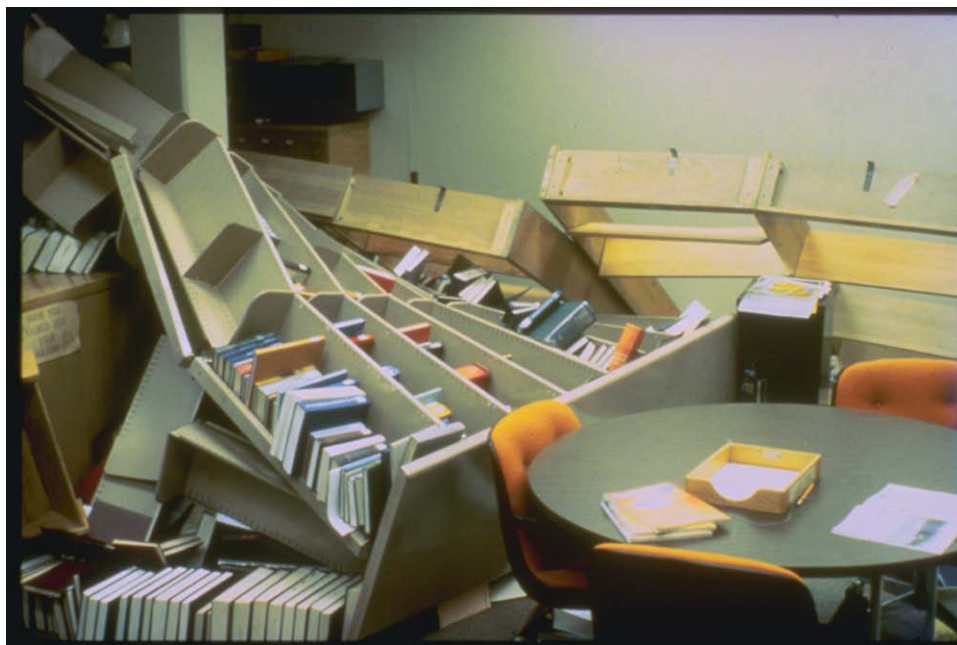
Figure 6.5.2.1-1 Failure of poorly anchored wood and metal book shelves at the Lawrence Livermore Laboratory, Livermore, California (NGDC, 2009).

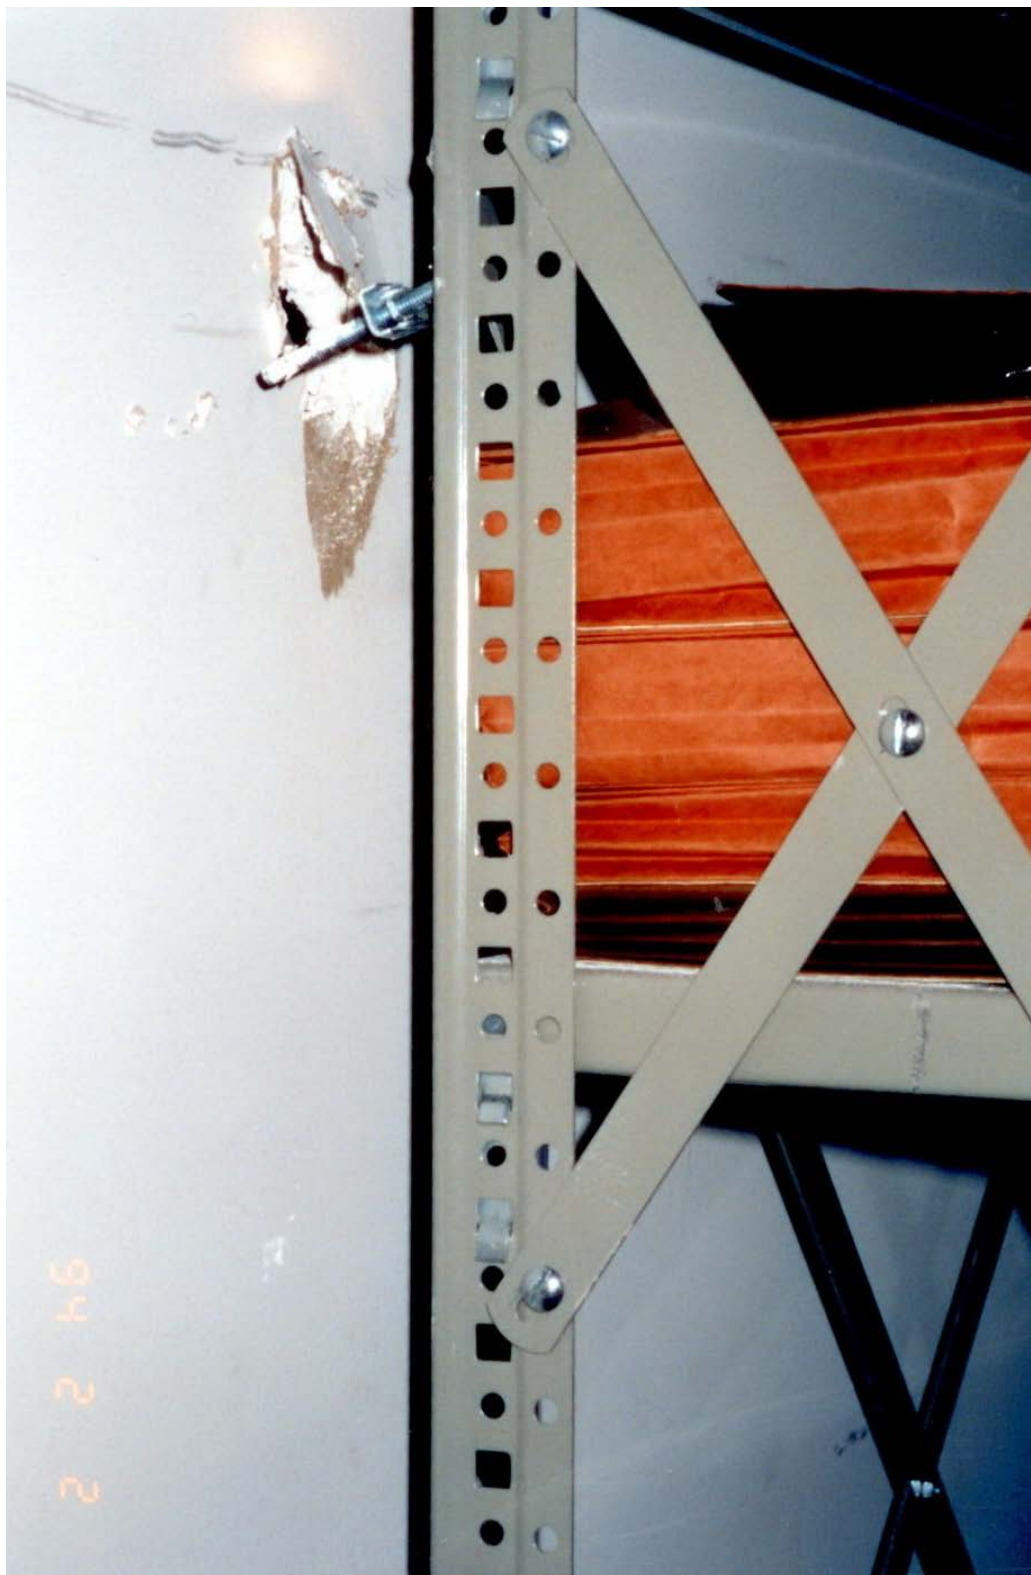
Figure 6.5.2.1-2 Failure of poorly anchored shelving; toggle bolt pulled out of gypsum board wall in the 1994 magnitude-6.7 Northridge Earthquake (Photo courtesy of Wiss, Janney, Elstner Associates).

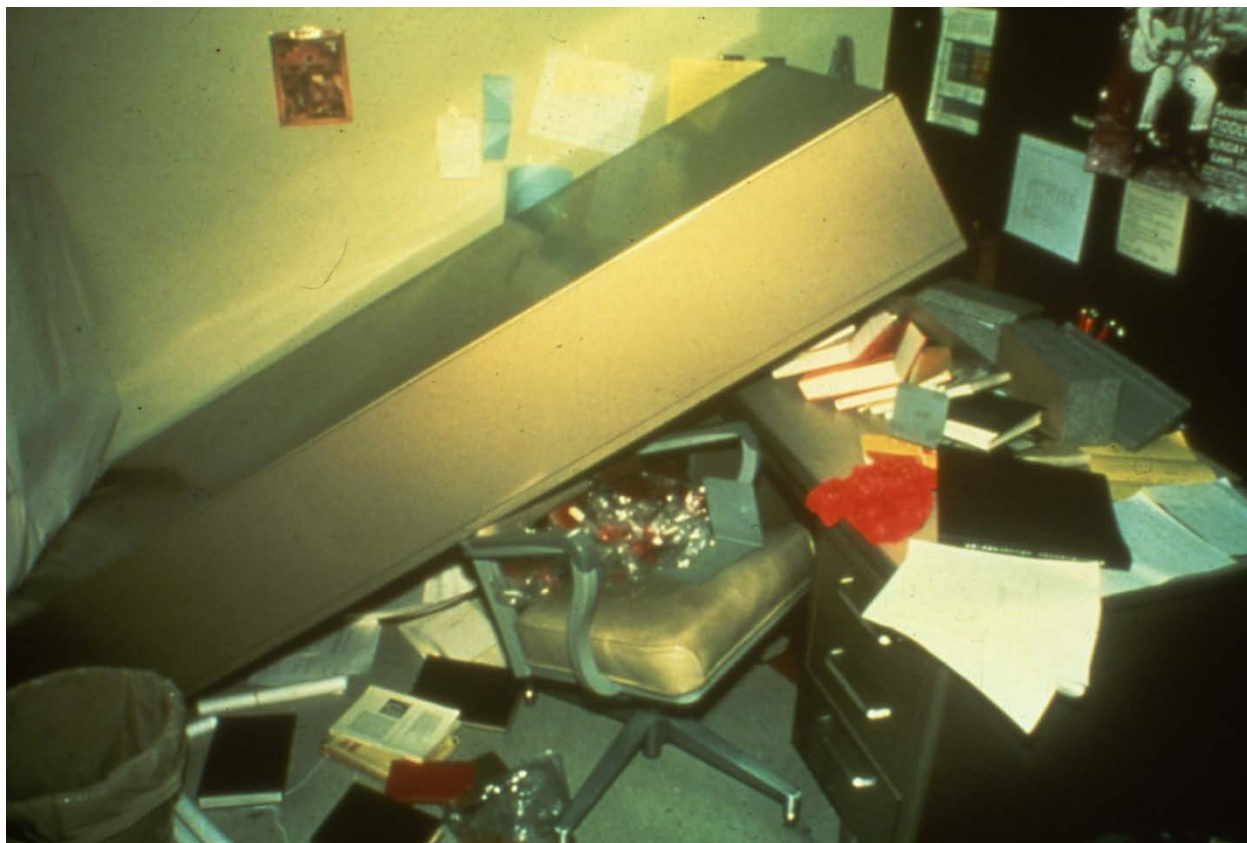
Figure 6.5.2.1-3 Bookcase overturned onto desk in the 1971 magnitude-6.6 San Fernando Earthquake (Photo courtesy of Degenkolb Engineers).

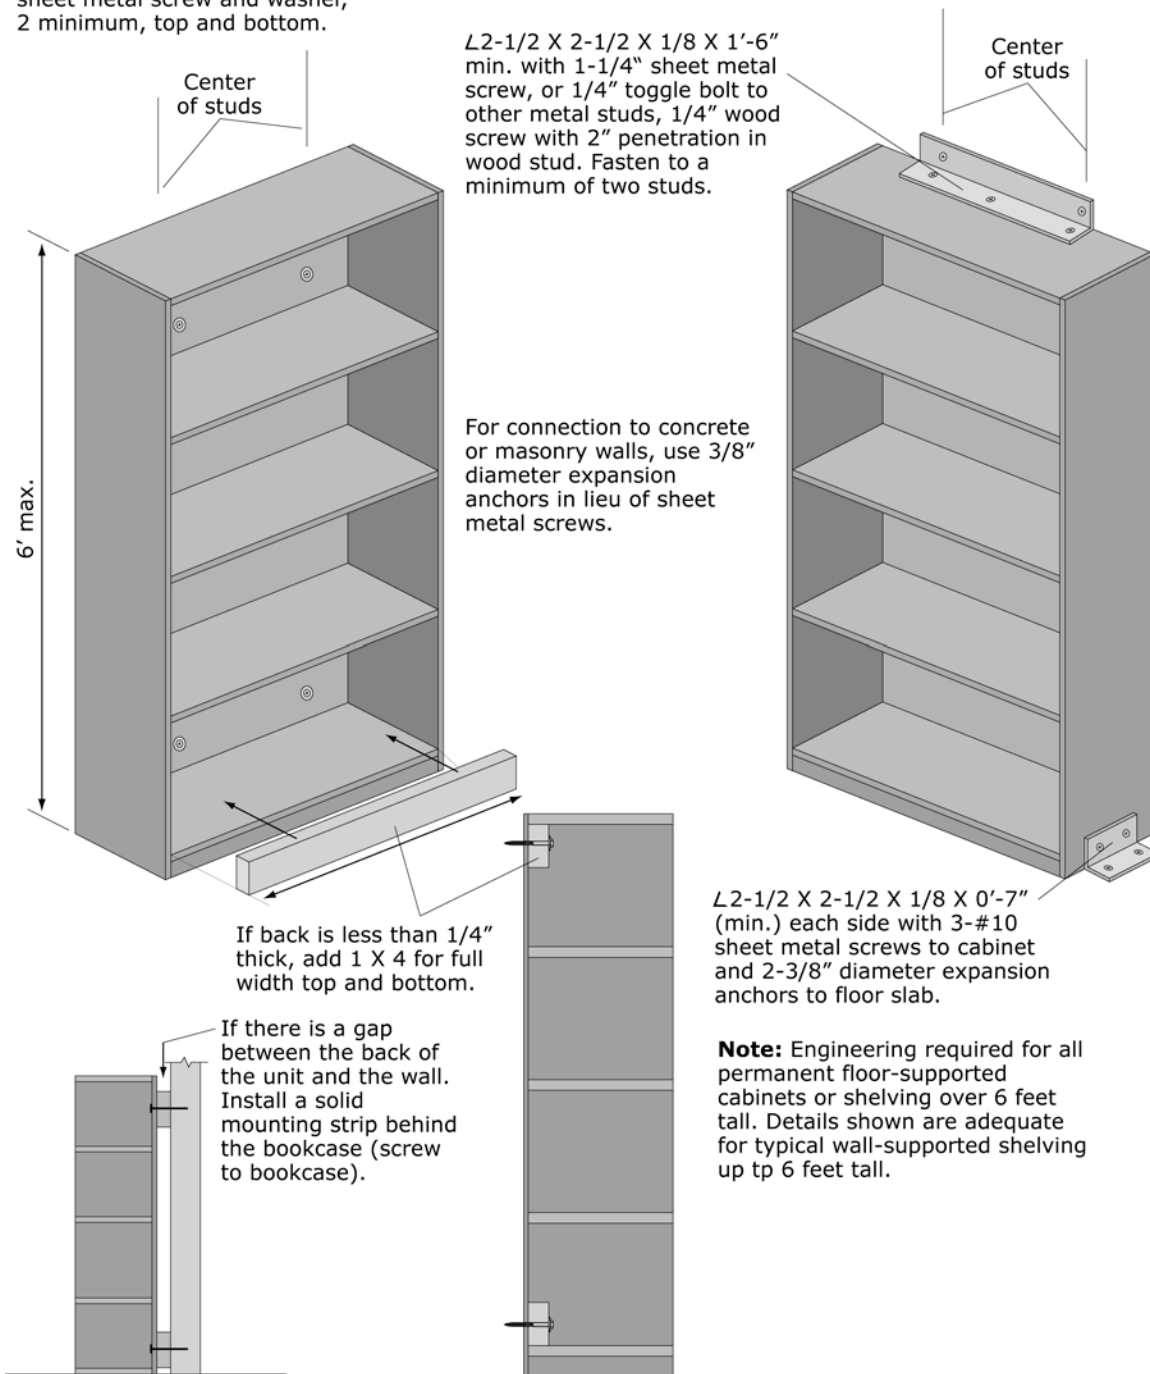
Where rear wall of bookcase is wood or metal with mechanical connection to bookcase framing, unit may be fastened directly to wall studs with 1/4" sheet metal screw and washer, 2 minimum, top and bottom.

2 X 4 min. wood stud or 20 ga.
min. metal stud @ 24" oc max.
Verify that studs run full height
to floor above or are adequately
braced to structural framing

Figure 6.5.2.1-4 Bookshelves against wall (NE, ER).

- Permanent floor-supported shelving or storage cabinets over 6 ft tall must be designed as architectural components per ASCE 7-10, *Minimum Design Loads for Buildings and Other Structures* (ASCE, 2010). Bracing and anchorage for these units should be designed considering the weight of the unit and weight of shelved contents. The details shown in Figure 6.5.2.1-4 and 6.5.2.1-5 are for shelving units up to 6 feet tall.

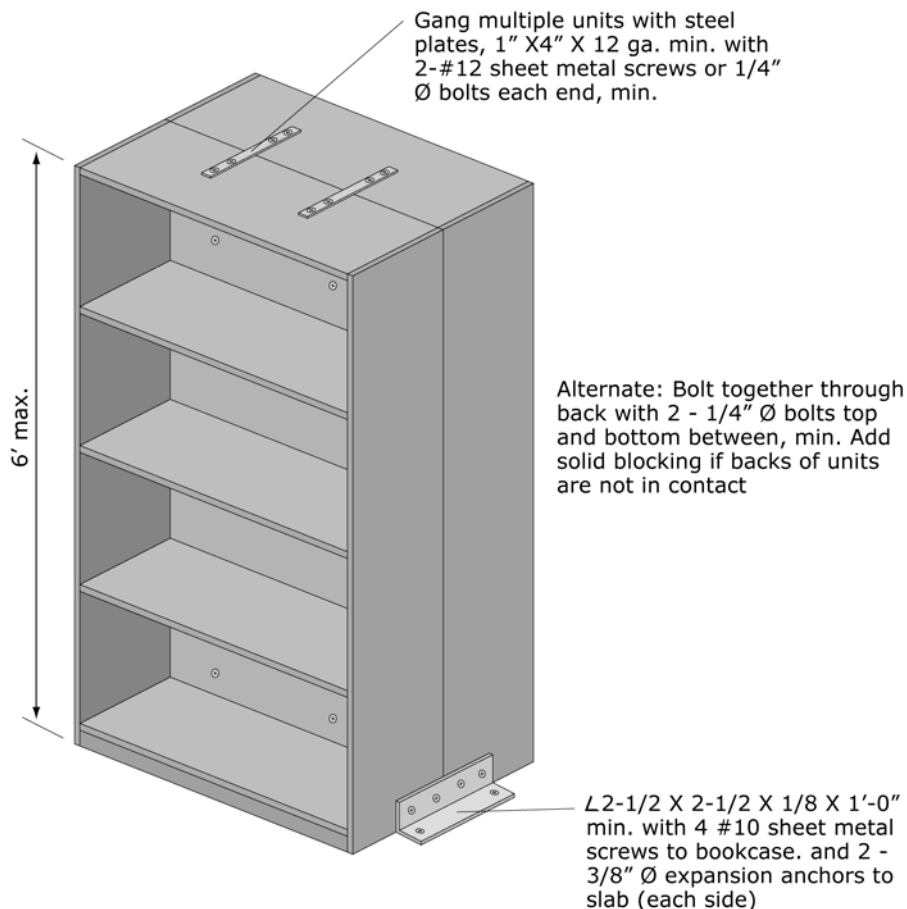
Note: Engineering required for all permanent floor-supported cabinets or shelving over 6 feet tall. Details shown are adequate for typical shelving 6 feet or less in height.

Figure 6.5.2.1-5 Anchorage of freestanding book cases arranged back to back (NE, ER).

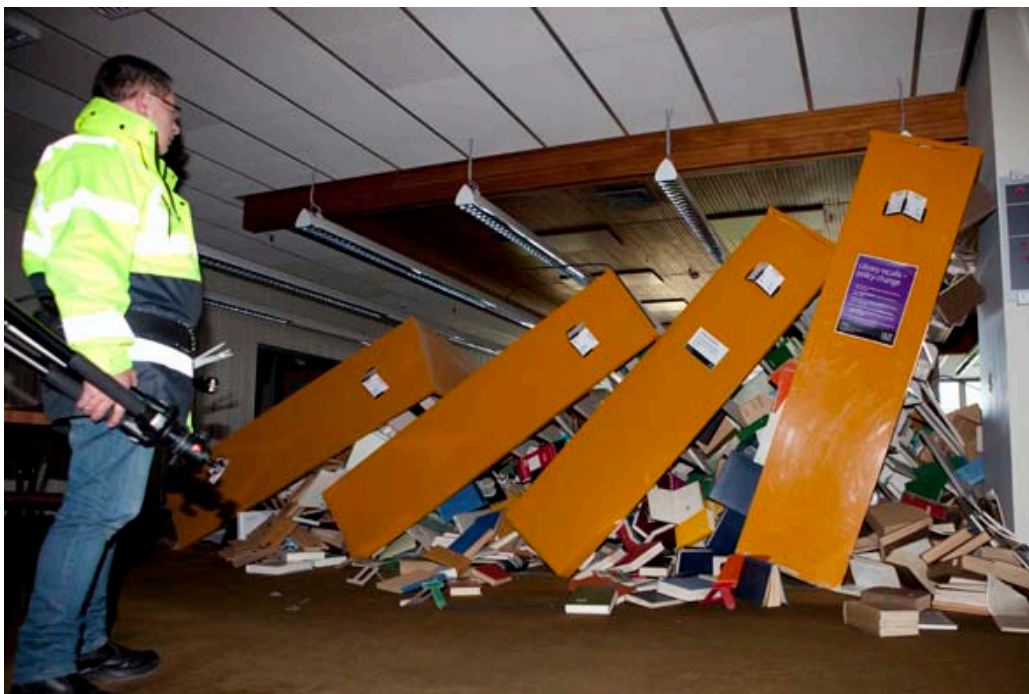
Figure 6.5.2.2-1 Photo showing collapsed library shelving in the 2010 magnitude-7.1 Canterbury New Zealand Earthquake (Photo courtesy of University of Canterbury).

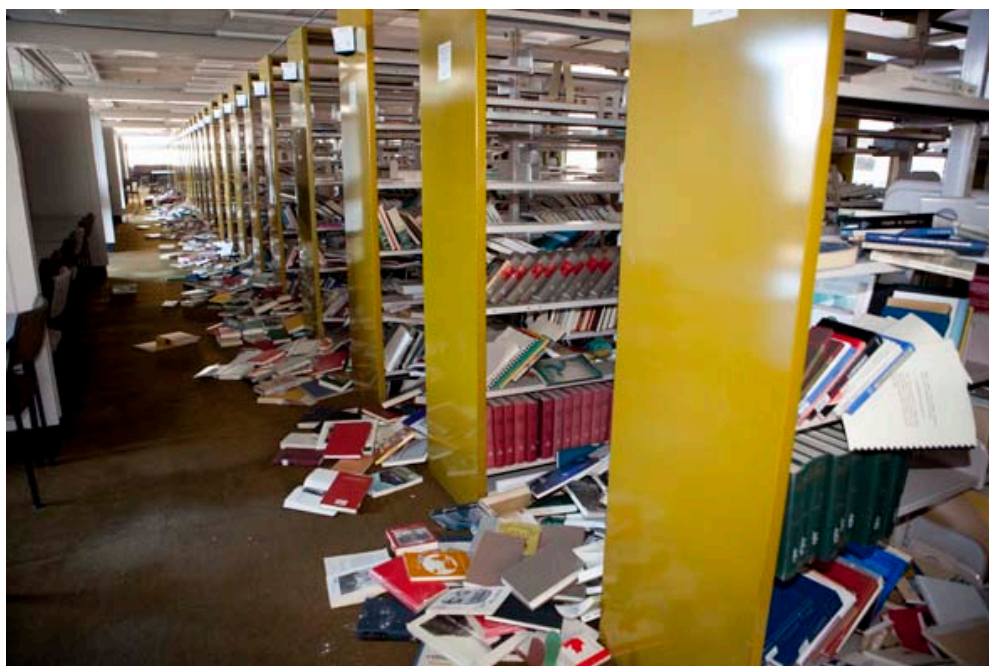
Figure 6.5.2.2-4 Shelving units with longitudinal ties did not fall over but all of the contents spilled to the floor in the 2010 Canterbury Earthquake. The use of lips or wires would have prevented the damage.(Photo courtesy of University of Canterbury).

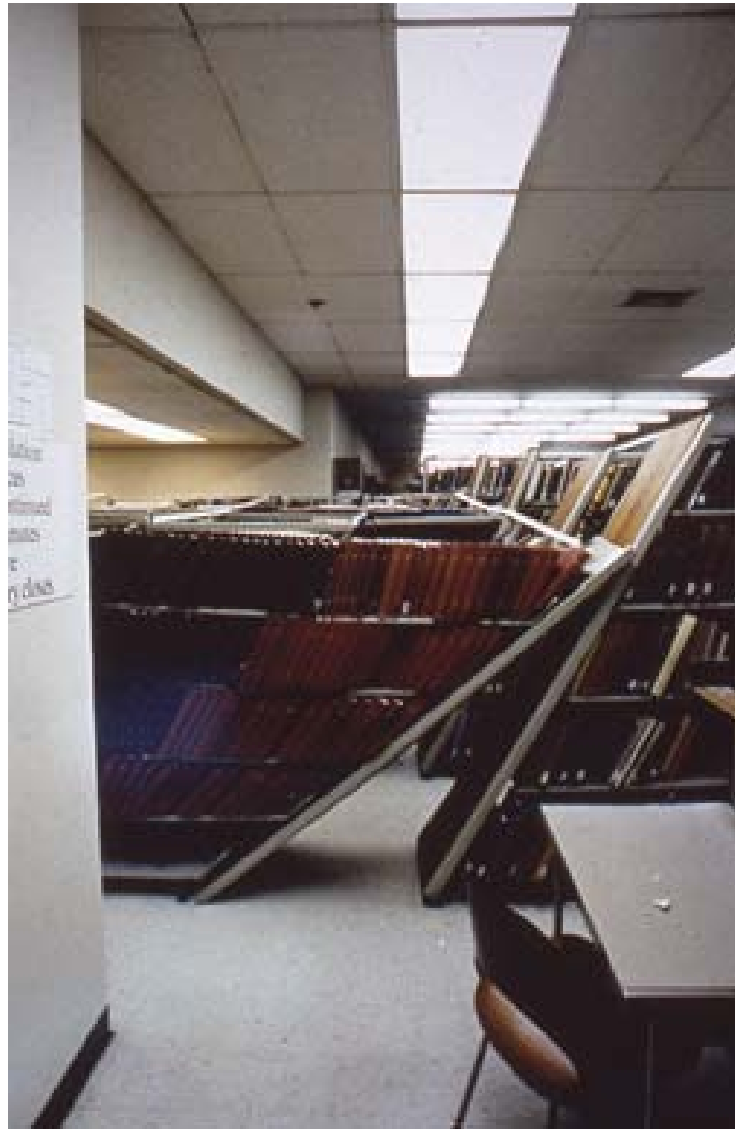
Figure 6.5.2.2-3 Longitudinal failure of library shelving units (Photo courtesy of NISEE-PEER, U.C. Berkeley). Transverse ties used to tie units together but this was not enough to prevent longitudinal failure.

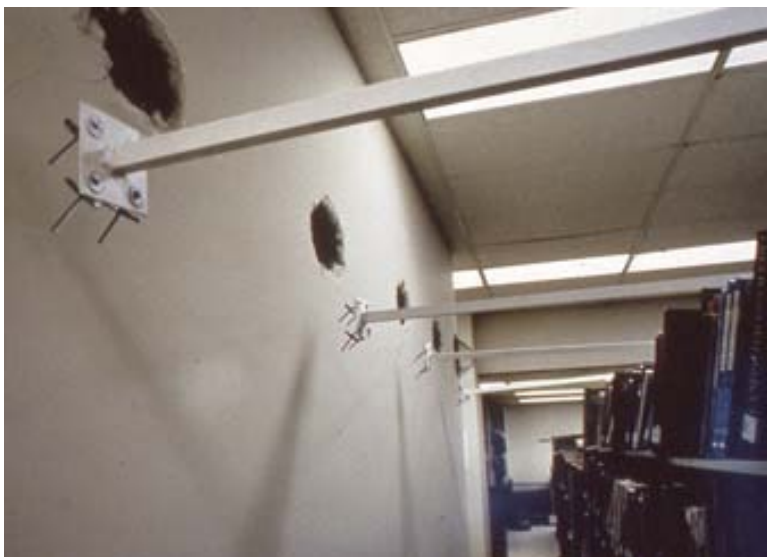
Figure 6.5.2.2-2 Failure of overhead transverse bracing for bookshelves were anchored to gypsum board partition in the 1984 magnitude-6.2 Morgan Hill Earthquake (Photo courtesy of Santa Clara County Office of Emergency Services). The anchors were not attached to wall studs, only to gypsum board.

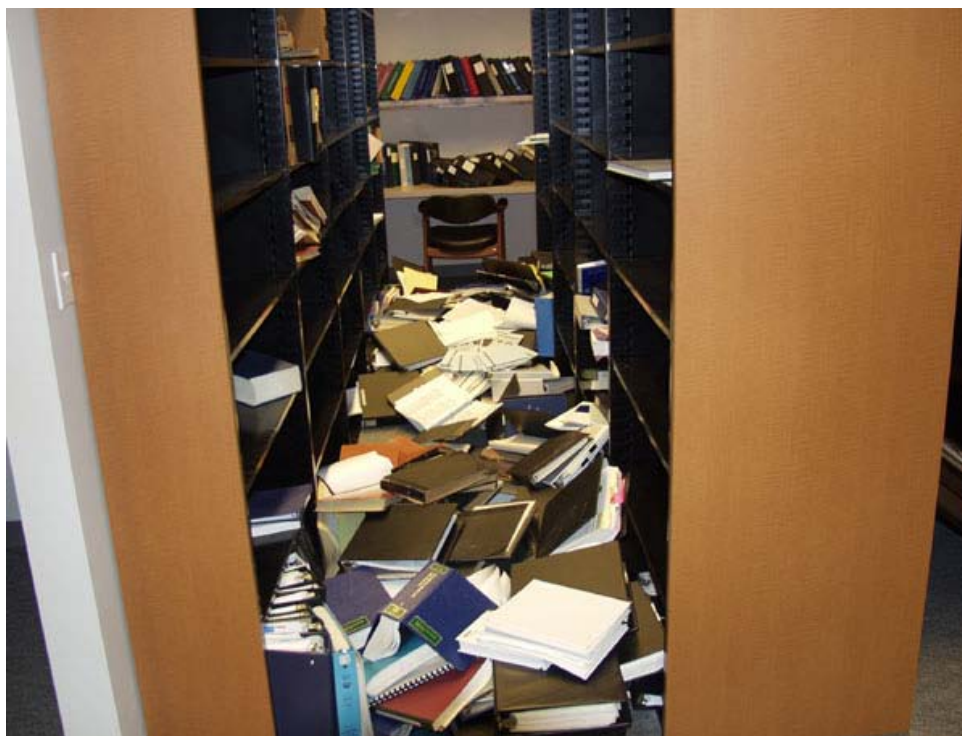
Figure 6.5.2.2-5 These shelving units remained in place but all of the contents spilled in the 2010 magnitude-6.5 Eureka, California Earthquake (Photo courtesy of Steve Mahin, PEER).

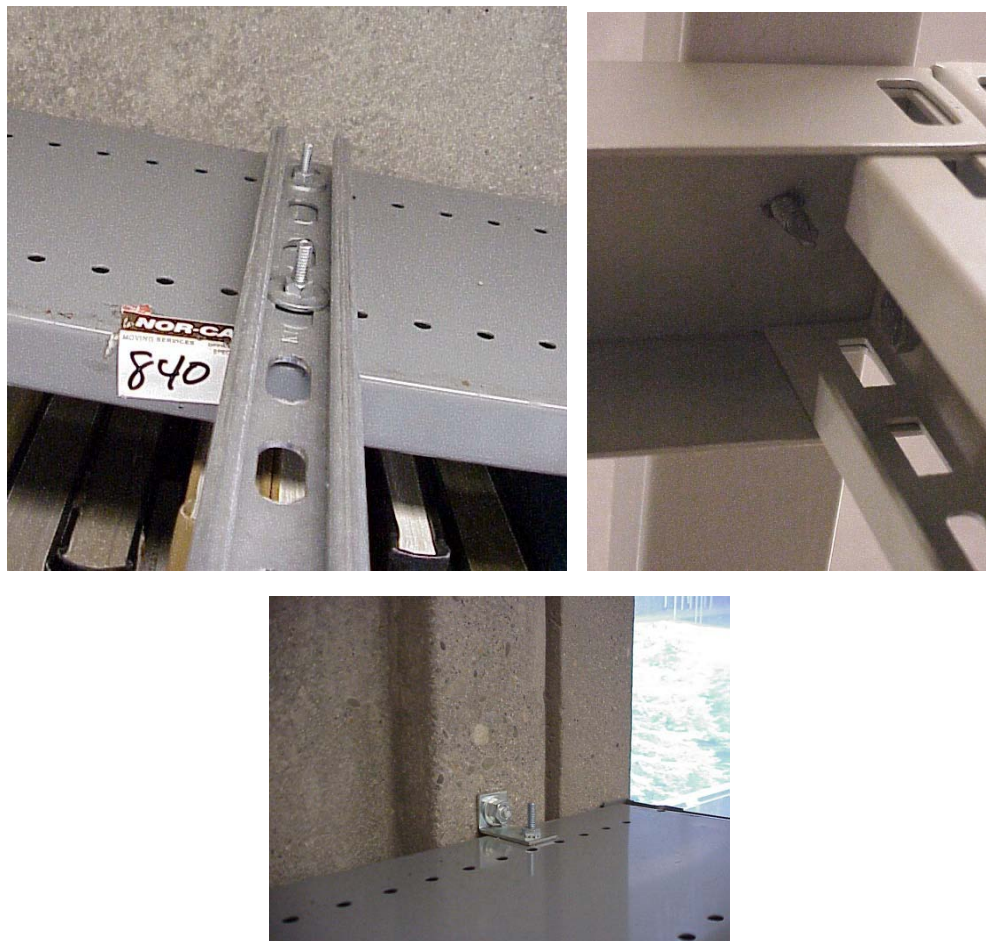
Figure 6.5.2.2-6 Examples of struts and hardware used to retrofit library shelving at the University of California, Berkeley (Photos courtesy of Mary Comerio, Dept. of Environmental Design, University of California Berkeley).

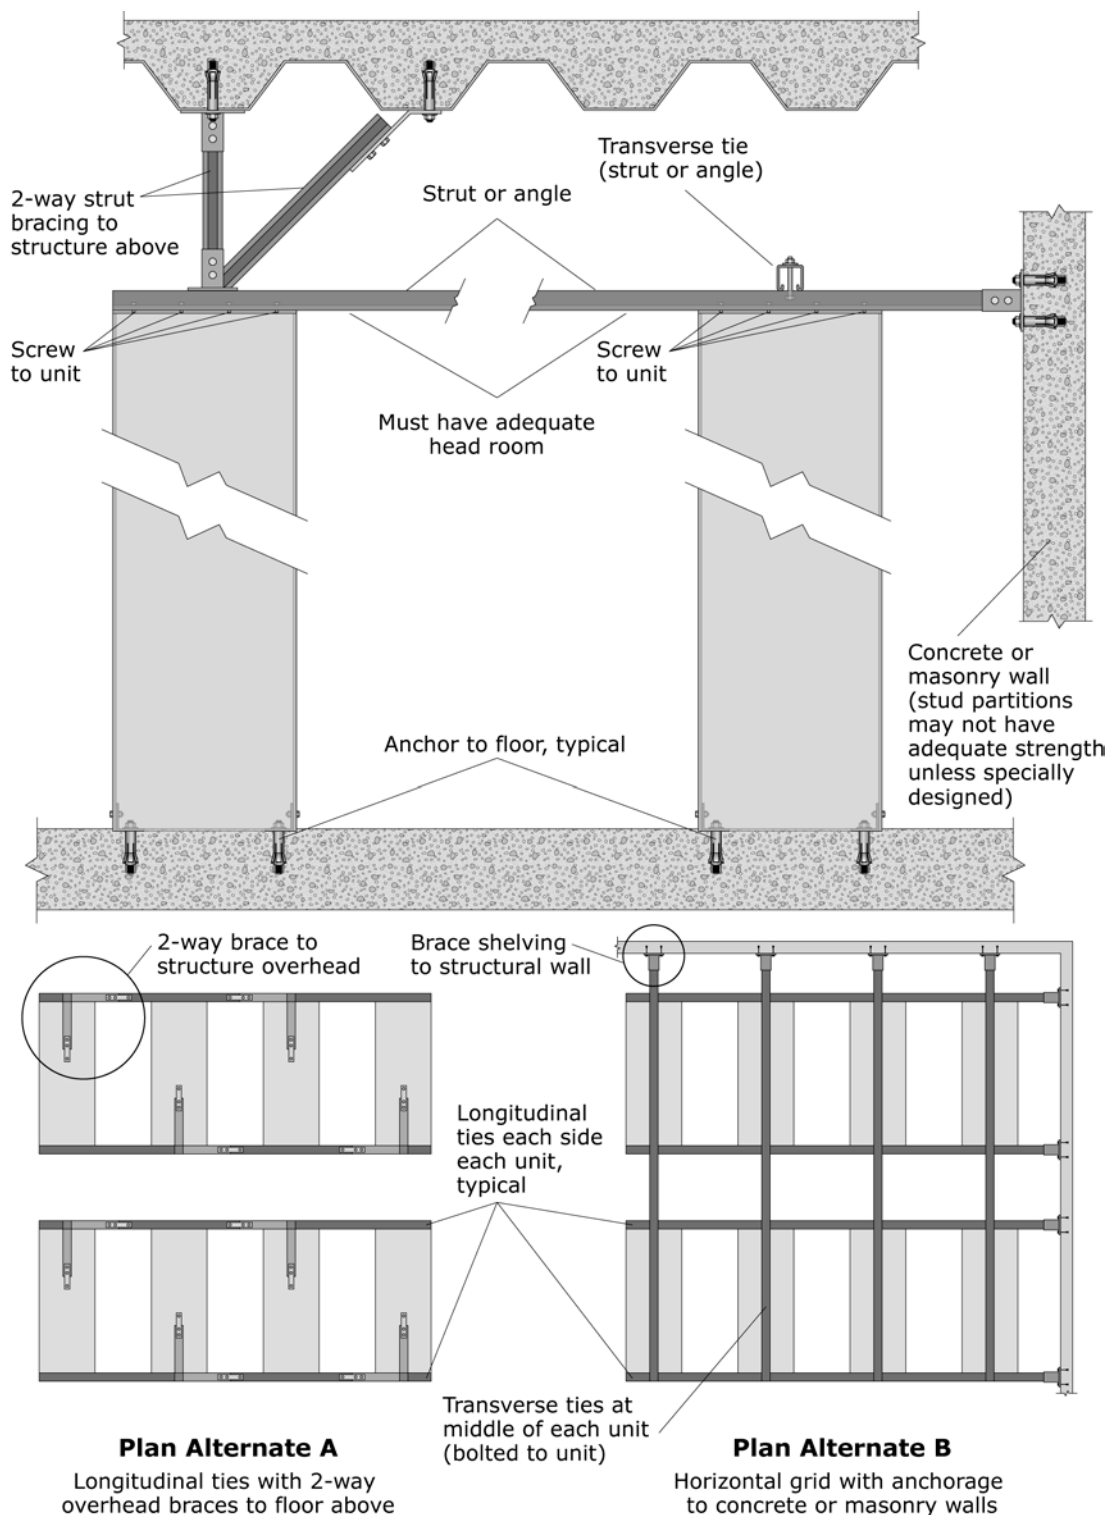
Figure 6.5.2.2-8 Overhead restraints for library and other shelving (ER).

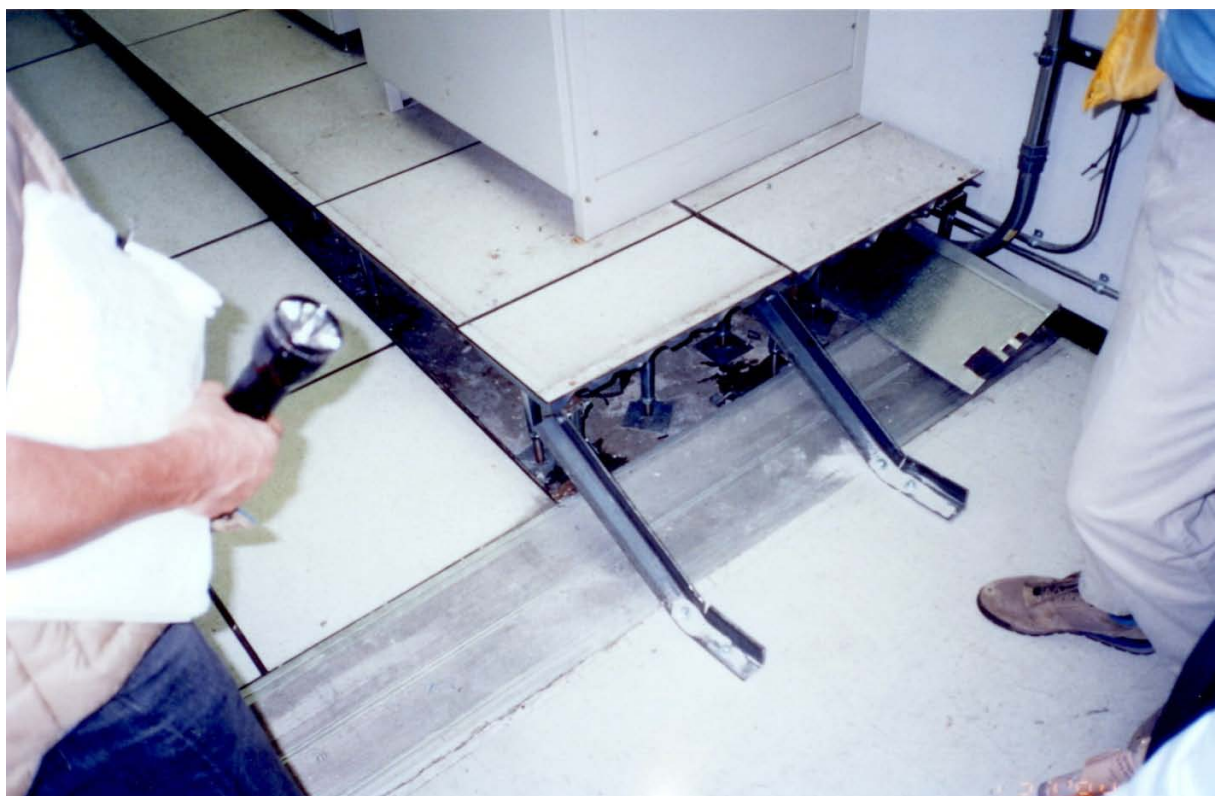
Figure 6.5.3.1-1 Temporary bracing for access floor collapsed in the 1994 magnitude-6.7 Northridge Earthquake (Photo courtesy of Wiss, Janney, Elstner Associates).

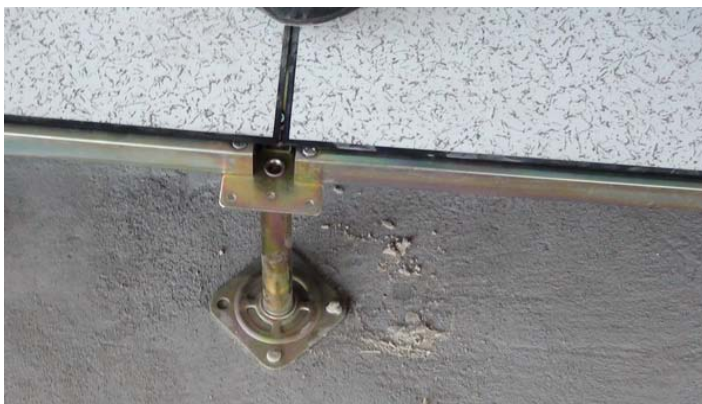
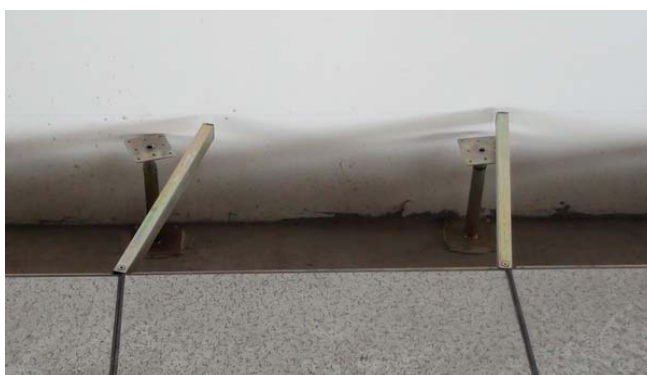
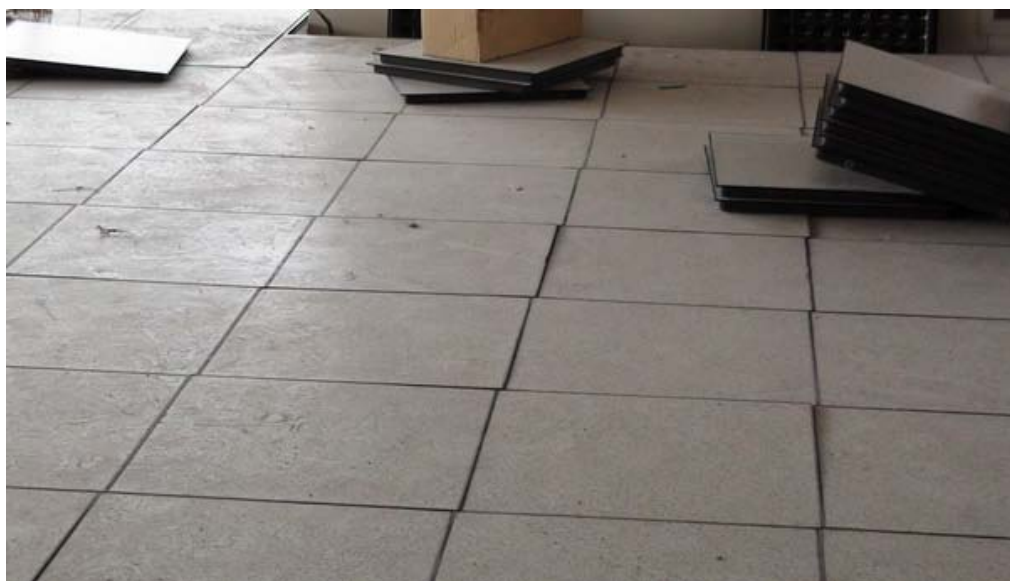
Figure 6.5.3.1-2 Damage to access floor with short anchored pedestals in the 2010 magnitude-6.7 Chile Earthquake; floor did not have lateral bracing. Note many tiles misaligned (Photos courtesy of Antonio Iruretagoyena, Rubén Boroschek & Associates).

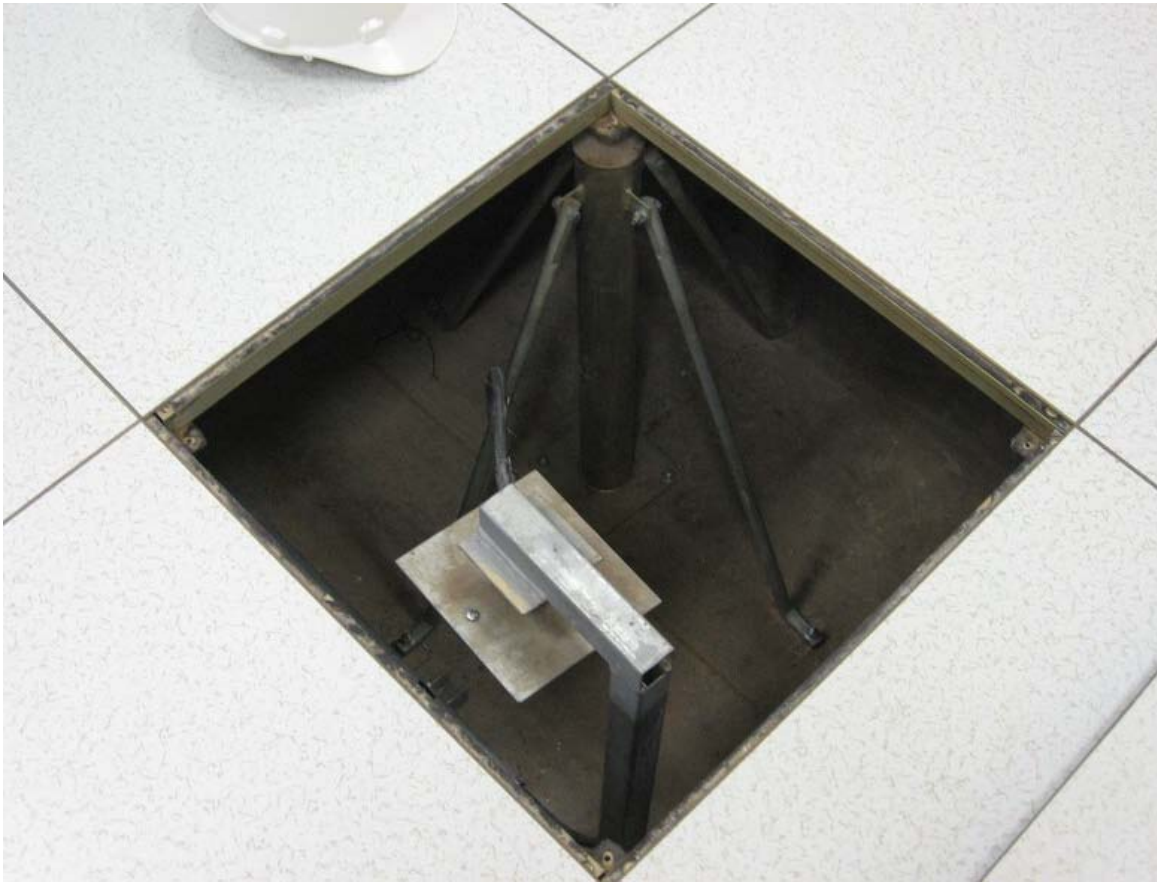
Figure 6.5.3.1-3 Undamaged access floor with braced pedestals in the 2010 Chile Earthquake (Photo courtesy of Rodrigo Retamales, Rubén Boroschek & Associates).

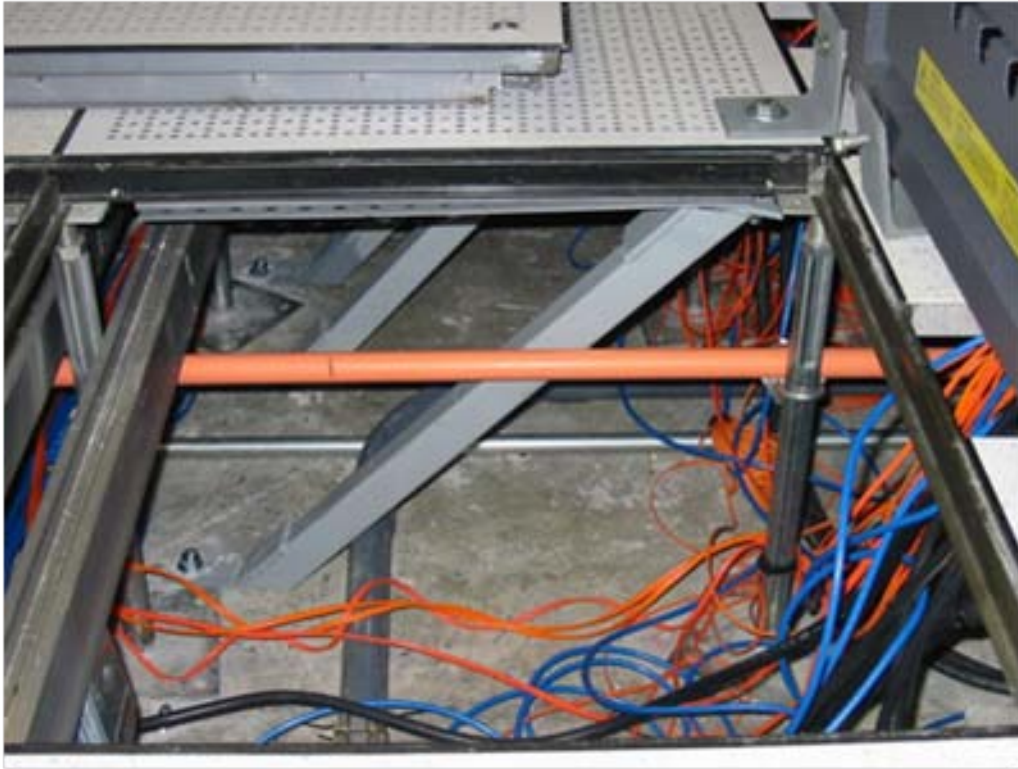
Figure 6.5.3.1-4 Raised floor braced with strut (Photo courtesy of Maryann Phipps, Estructure).

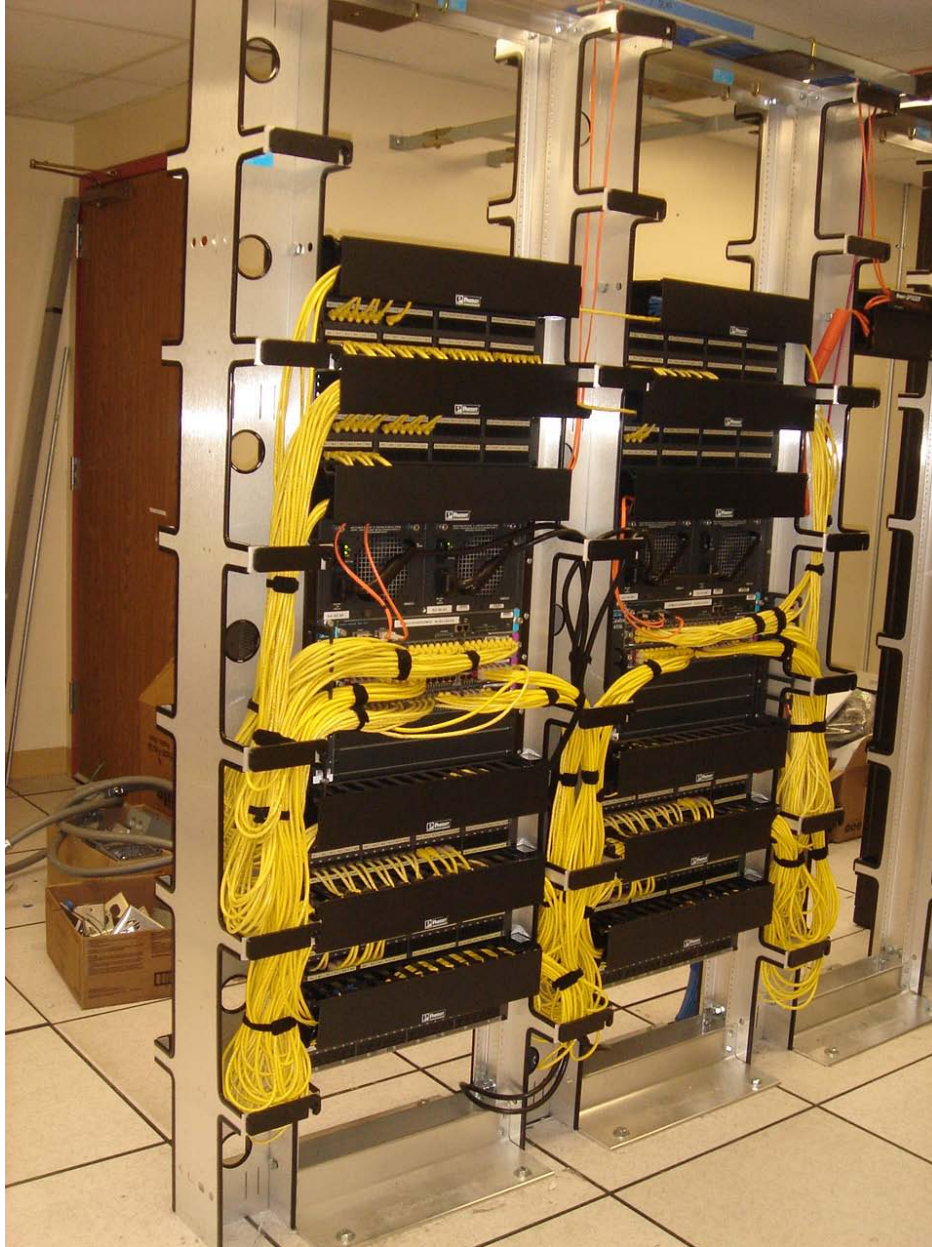
Figure 6.5.3.1-5 Data rack bolted through access floor to supplemental strut bracing below (Photo courtesy of Maryann Phipps, Estructure).

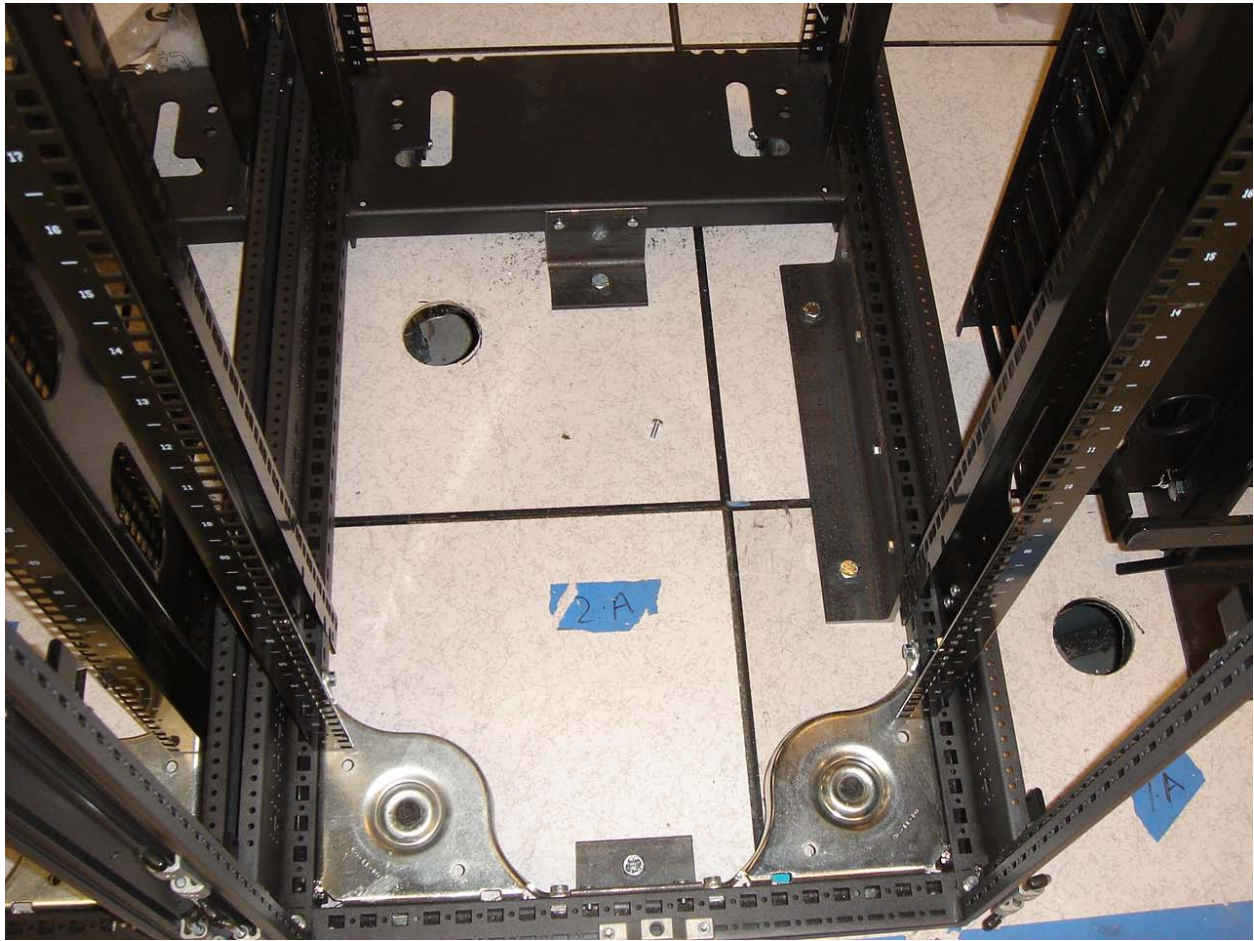
Figure 6.5.3.1-6 Base of data cabinet with supplemental angles bolted to strut bracing below floor (Photo courtesy of Maryann Phipps, Estructure).

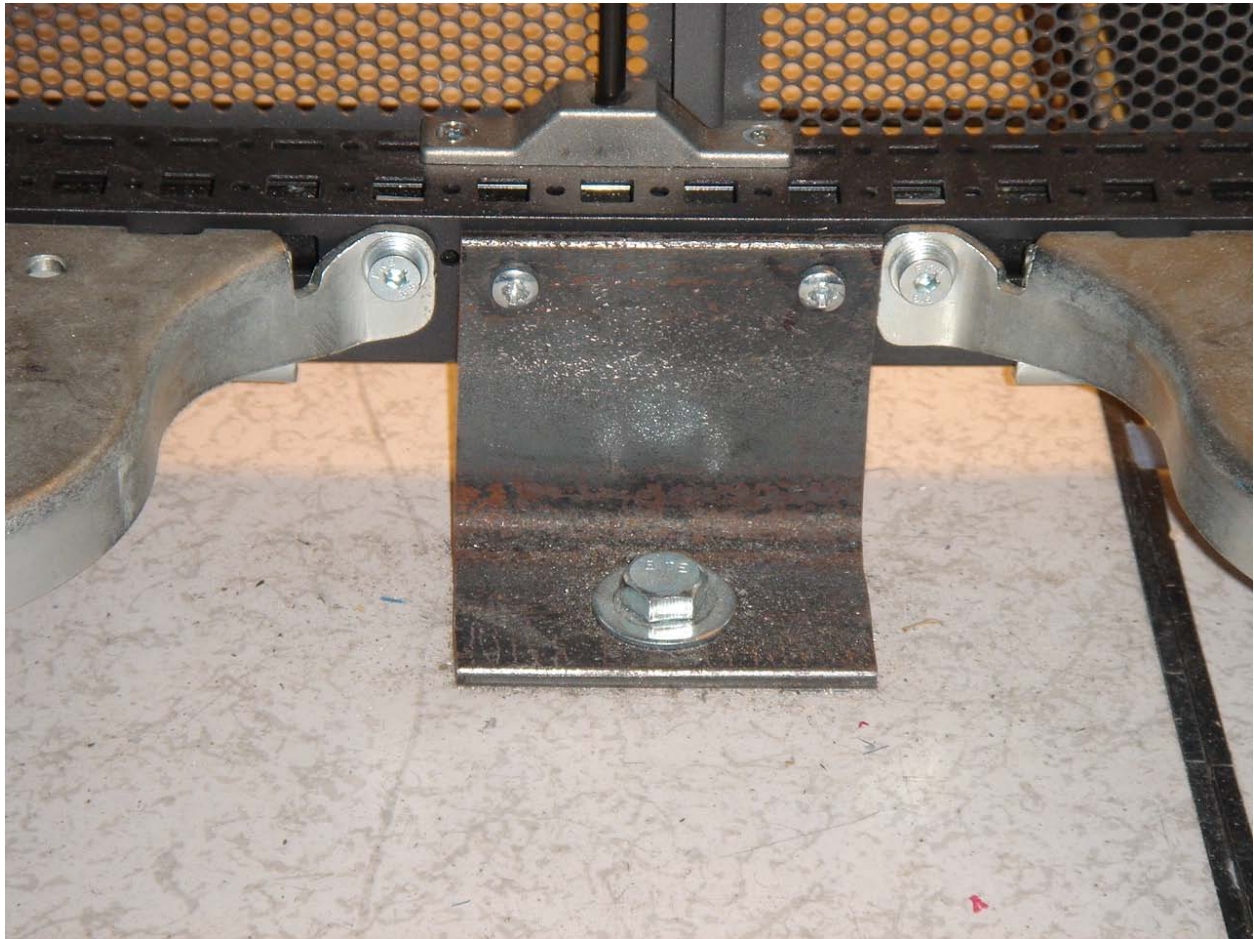
Figure 6.5.3.1-7 Close-up of supplemental angles connecting data cabinet to strut bracing below floor (Photo courtesy of Maryann Phipps, Estructure).

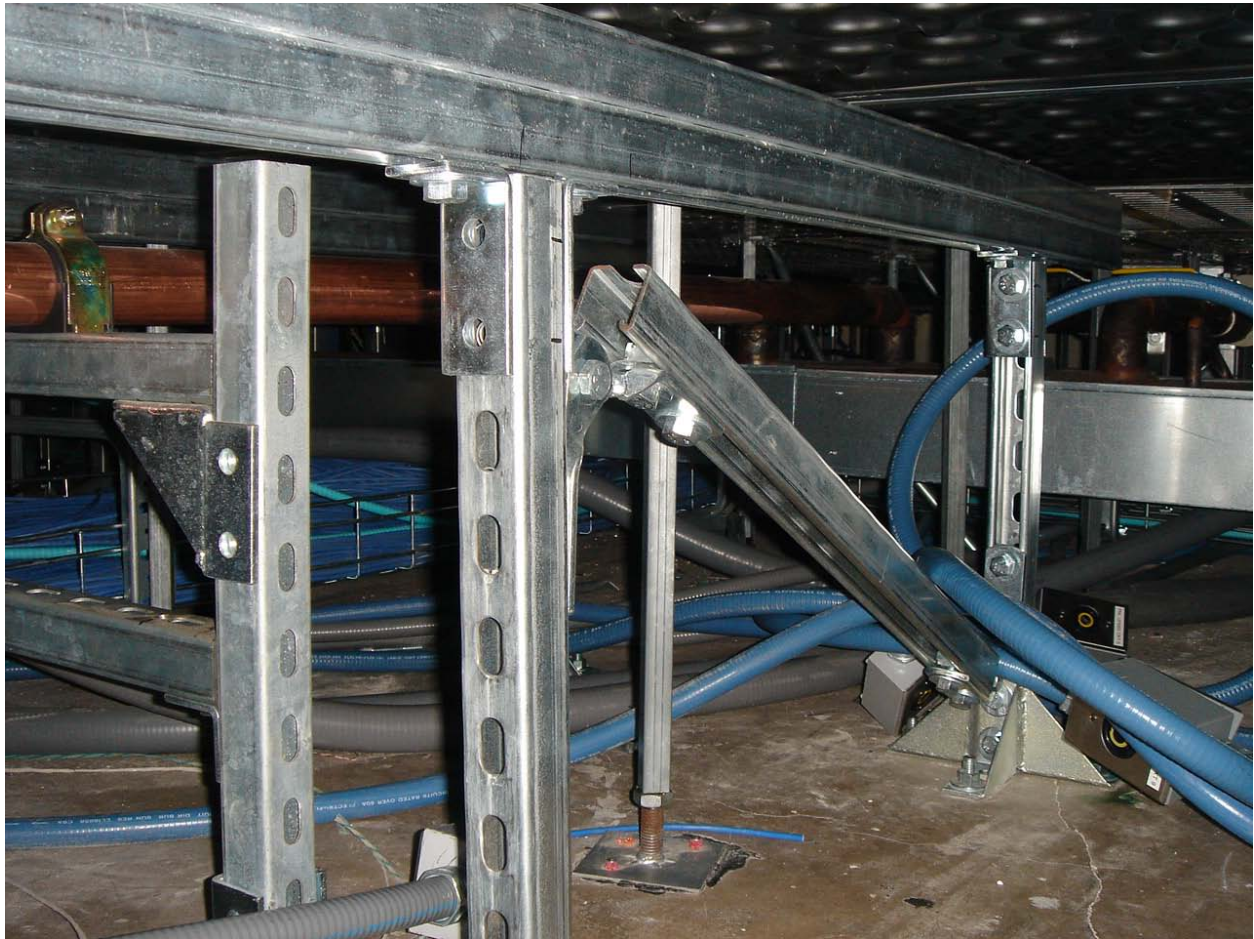
Figure 6.5.3.1-8 Strut framing added to brace data cabinet located on access floor. Bolts from angles above are connected to strut framing below (Photo courtesy of Maryann Phipps, Estructure).

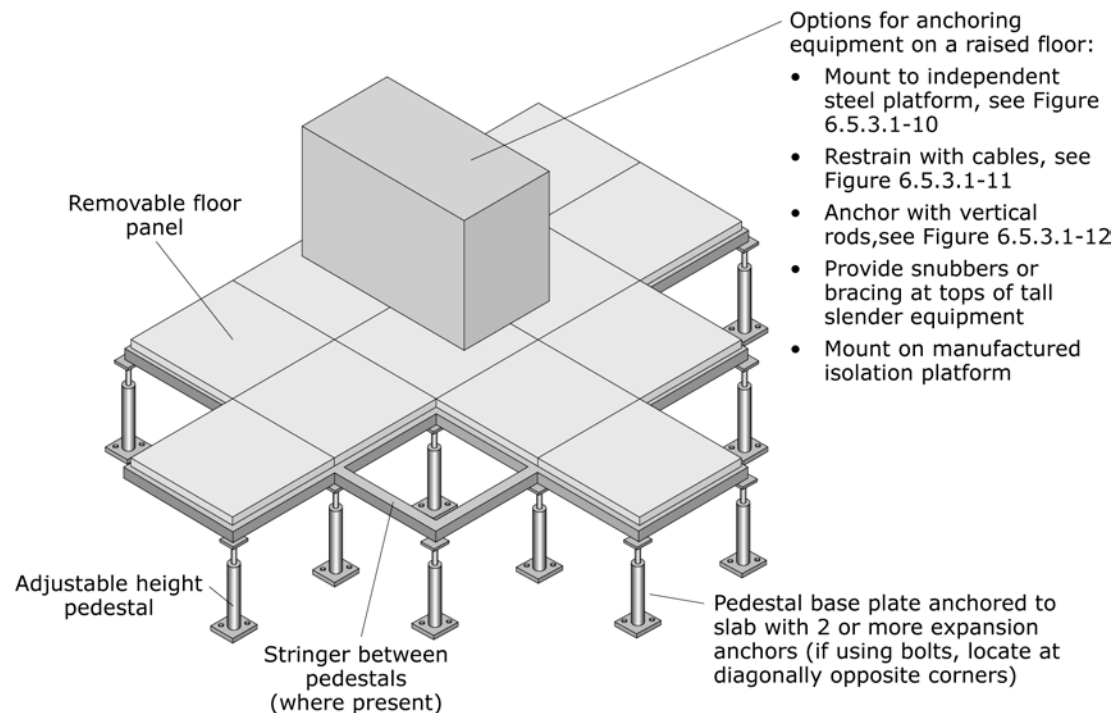
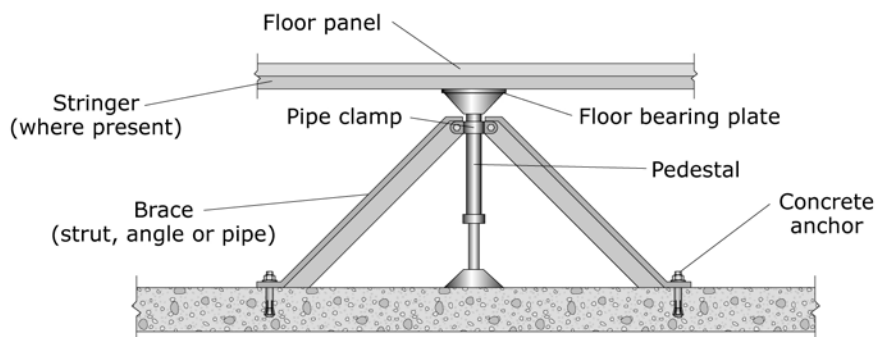
Cantilevered Access Floor Pedestal

Braced Access Floor Pedestal

(use for tall floors or where pedestals are not strong enough to resist seismic forces)

Figure 6.5.3.1-9 Equipment mounted on access floor (ER).
